CASE STUDY:
Tower of London

Moisture monitoring in Heritage Building

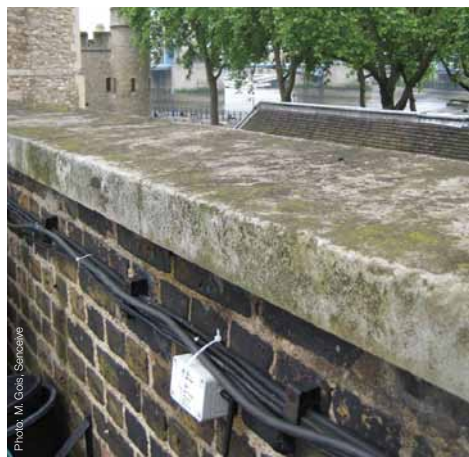
Photo: M. Goss, Senceive

We integrated a humidity and temperature sensor into our FlatMesh product, and deployed a network of approximately 20 nodes. Deployment was particularly difficult as the nodes had to be kept out of sight from the public and hence placed in awkward positions, and made even more difficult by the thick walls which attenuate the wireless signals.

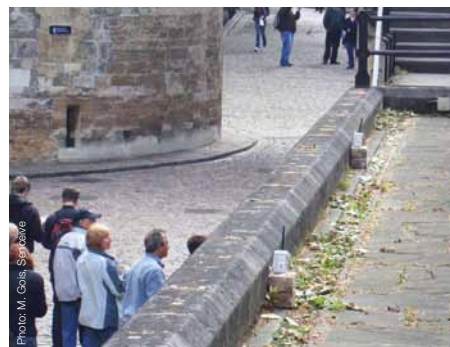
Photo: M. Goss, Senceive

Senceive's solar powered GPRS unit was also deployed outdoors to relay the data to a remote server, giving live access to humidity and temperature data across the site.
